**Flood Control Project Maintenance
Levee Inspections**
LMA District Cover Sheet
Spring 2018 Levee Inspection Results

Reclamation District No. 0501 Ryer Island

Spring 2018 Levee Inspection Results

Waterway			Bank	Unit Miles
Unit No. 01 Steamboat Slough			Right	6.71
	Spring (March - May)	Summer (June - August)	(September - November) Fall	Winter (December - February)
Unit Maintenance Rating (Fall Only)				
Date of Inspection	3/13/2018 - 3/13/2018			
DWR Inspector	Keith Millard			
Accompanied By

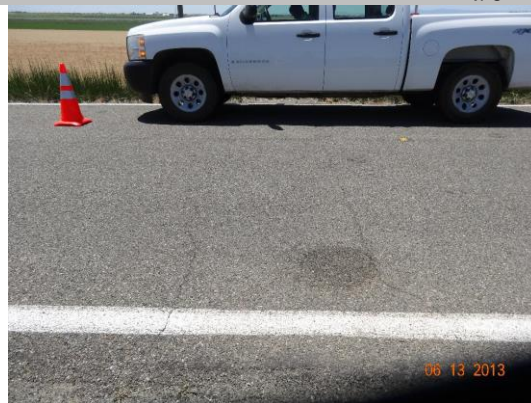
Photo 1 of 3 : UCIP_SP_2018_32548_59057.jpg

FS_ID:32548
DS_ID:21079
EP_NO: 2446
Repair Type: Non-Urgent
Crossing Status: Found
UCIP Comments: Permit documents indicate that pipe does not appear to be properly grouted. Crossing needs to be properly abandoned per CVFPB Title 23--need to find owner. Also recommend removing vegetation along pipe alignment to conduct proper inspection of structure and appurtenances.
FIELD_STRUCT_DESC: *ABANDONED* 8-inch steel irrigation discharge pipe through the levee, 6 feet below the crown. Pump on the waterside (WS). Steel plate welded on the WS end. 10-inch steel pipe approximately 5 feet downstream. (Plans to replace an existing pump and pipeline with a new pump and pipeline authorized under Permit No. 2446, 1957 - Doris R. Geary). [Additional Reference(s): DWR Levee Log, 2005. USACE Sacramento O&M Manual 105, April 1959, (HLM 0.6)].
FS Date: 6/13/2013

View of levee crown at crossing.

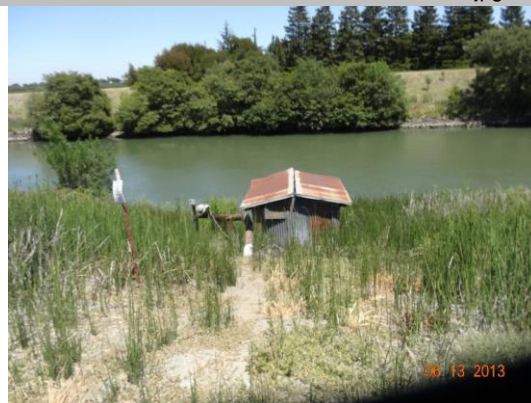
Photo 2 of 3 : UCIP_SP_2018_32548_59058.jpg

Overview of waterward side. Two crossings, 10 inch and 8 inch pipelines, less than 5 feet apart.

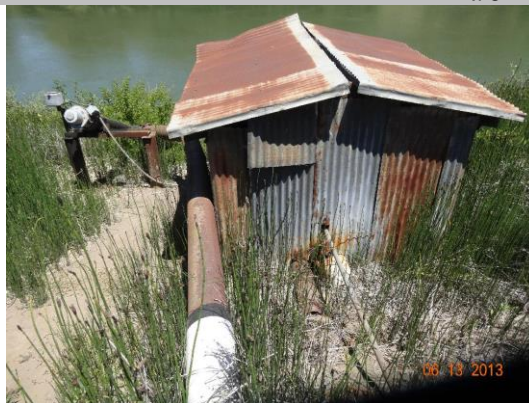
Photo 3 of 3 : UCIP_SP_2018_32548_59056.jpg

Comment Code					
Inspector Comment					
FS_ID:32548 DS_ID:21079 EP_NO: 2446 Repair Type: Non-Urgent Crossing Status: Found UCIP Comments: Permit documents indicate that pipe does not appear to be properly grouted. Crossing needs to be properly abandoned per CVFPB Title 23--need to find owner. Also recommend removing vegetation along pipe alignment to conduct proper inspection of structure and appurtenances. FIELD_STRUCT_DESC: *ABANDONED* 8-inch steel irrigation discharge pipe through the levee, 6 feet below the crown. Pump on the waterside (WS). Steel plate welded on the WS end. 10-inch steel pipe approximately 5 feet downstream. (Plans to replace an existing pump and pipeline with a new pump and pipeline authorized under Permit No. 2446, 1957 - Doris R. Geary). [Additional Reference(s): DWR Levee Log, 2005. USACE Sacramento O&M Manual 105, April 1959, (HLM 0.6)]. FS Date: 6/13/2013

Pump house is associated with abandoned 8 inch pipe.

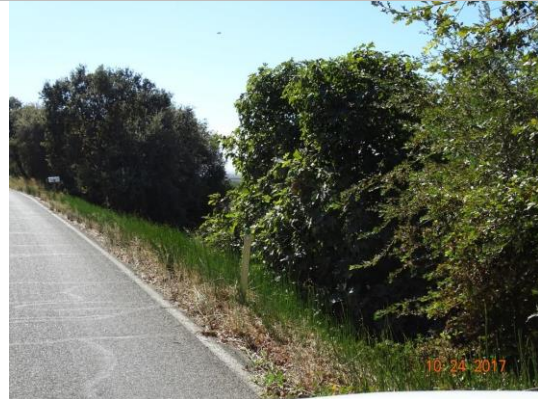
Photo 1 of 1 : SP_2018_RD0501_172_12_20180305_00001.jpg

LM Start	0.99	Rating **	M	Issue No.	12
LM End	0.99	Issue Type +	En	Location *	LS
Category	Earthen Levee			GPS Latitude/Longitude	
				Start	End
Item	Vegetation			38.272650 °	38.272650 °
				-121.603960 °	-121.603960 °
DWR ID	DWR_RD0501_04_f_2017_12				
Comment Code					
V6 : Landscaping					
Inspector Comment					
Trim fig and other trees to allow inspection and access to landside slope and toe.

Trim fig and other trees to allow inspection and access to landside slope and toe.

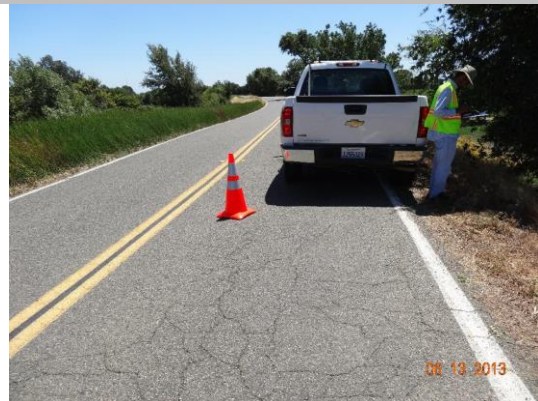
Photo 1 of 3 : UCIP_SP_2018_50021_59065.jpg

Comment Code					
Inspector Comment					
FS_ID:50021 DS_ID:21072 EP_NO: N/A Repair Type: Urgent Crossing Status: Found UCIP Comments: 8/22/2016 Assume conditions at this crossing have remained the same--pipe wall is still deteriorating. Unable to locate crossing due to dense vegetation along both WS and LS slopes. Recommend removing vegetation along pipe alignment to conduct proper inspection of structure and appurtenances. (DWR UCIP - omagana)6/13/2013 Pipe has deteriorated--holes present on landward side. Need to contact owner. Unable to determine if crossing is still being used. Dense vegetation limits the inspector's visibility to identify signs of pipe failure (leaks) along the waterward slope. Recommend removing vegetation along pipe alignment to conduct proper inspection of structure and appurtenances. (DWR UCIP - omagana) FIELD_STRUCT_DESC: *ABANDONED* 8-inch steel irrigation discharge pipe through the levee, 2.7 feet below the crown. Pump on the waterside (WS). Steel plate welded on the WS end. Unable to confirm if plate is still present in 2016. [Additional Reference(s): DWR Levee Log, 2005. USACE Sacramento O&M Manual 105, April 1959, (HLM 1.1)]. FS Date: 8/22/2016

View of levee crown at crossing.

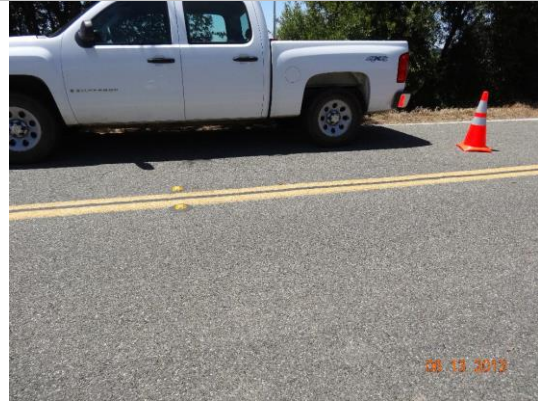
Photo 2 of 3 : UCIP_SP_2018_50021_59066.jpg

Comment Code						
Inspector Comment						
FS_ID:50021 DS_ID:21072 EP_NO: N/A Repair Type: Urgent Crossing Status: Found UCIP Comments: 8/22/2016 Assume conditions at this crossing have remained the same--pipe wall is still deteriorating. Unable to locate crossing due to dense vegetation along both WS and LS slopes. Recommend removing vegetation along pipe alignment to conduct proper inspection of structure and appurtenances. (DWR UCIP - omagana)6/13/2013 Pipe has deteriorated--holes present on landward side. Need to contact owner. Unable to determine if crossing is still being used. Dense vegetation limits the inspector's visibility to identify signs of pipe failure (leaks) along the waterward slope. Recommend removing vegetation along pipe alignment to conduct proper inspection of structure and appurtenances. (DWR UCIP - omagana) FIELD_STRUCT_DESC: *ABANDONED* 8-inch steel irrigation discharge pipe through the levee, 2.7 feet below the crown. Pump on the waterside (WS). Steel plate welded on the WS end. Unable to confirm if plate is still present in 2016. [Additional Reference(s): DWR Levee Log, 2005. USACE Sacramento O&M Manual 105, April 1959, (HLM 1.1)]. FS Date: 8/22/2016

View of levee crown at crossing.

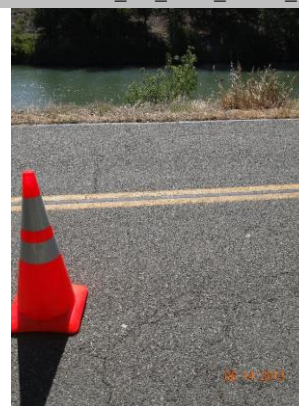
Photo 1 of 3 : UCIP_SP_2018_32550_59068.jpg

LM Start	1.08	Rating **	M	Issue No.	21
LM End	1.08	Issue Type +	En	Location *	
Category	Supplemental			GPS Latitude/Longitude	
				Start	End
Item	DWR UCIP Field Study			38.271400 °	38.271400 °
				-121.604368 °	-121.604368 °
DWR ID					
Comment Code					
Inspector Comment					
FS_ID:32550					
DS_ID:21073					
EP_NO: N/A					
Repair Type: Non-Urgent					
Crossing Status: Indicator Found					
UCIP Comments: Unable to determine if the pipe goes through the levee, need As-Built drawings; Need owner information.					
FIELD_STRUCT_DESC: 1.5-inch communications conduit of an unknown material through the levee, 2 feet below the crown. Pole and anchor on the landside (LS) slope. [Additional Reference(s): DWR Levee Log, 2005].					
FS Date: 6/13/2013

Levee crown at crossing.

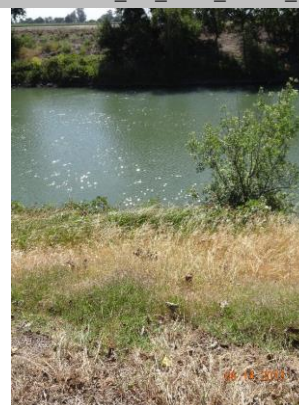
Photo 2 of 3 : UCIP_SP_2018_32550_59067.jpg

View of waterward side.

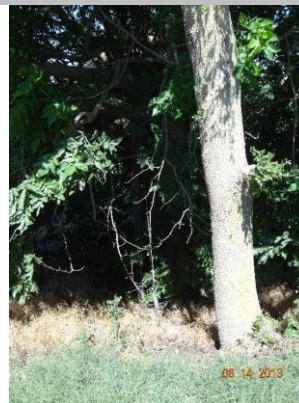
Photo 3 of 3 : UCIP_SP_2018_32550_59069.jpg

LM Start	1.08	Rating **	M	Issue No.	21 (cont)	
LM End	1.08	Issue Type +	En	Location *		
Category	Supplemental			GPS Latitude/Longitude		
				Start	End	
Item	DWR UCIP Field Study			38.271400 °	38.271400 °	
				-121.604368 °	-121.604368 °	
DWR ID						
Comment Code						
Inspector Comment						
FS_ID:32550						
DS_ID:21073						
EP_NO: N/A						
Repair Type: Non-Urgent						
Crossing Status: Indicator Found						
UCIP Comments: Unable to determine if the pipe goes through the levee. need As-Built drawings; Need owner information.						
FIELD_STRUCT_DESC: 1.5-inch communications conduit of an unknown material through the levee, 2 feet below the crown. Pole and anchor on the landside (LS) slope. [Additional Reference(s): DWR Levee Log, 2005].						
FS Date: 6/13/2013

View of landward side--power pole and guy wire under trees.

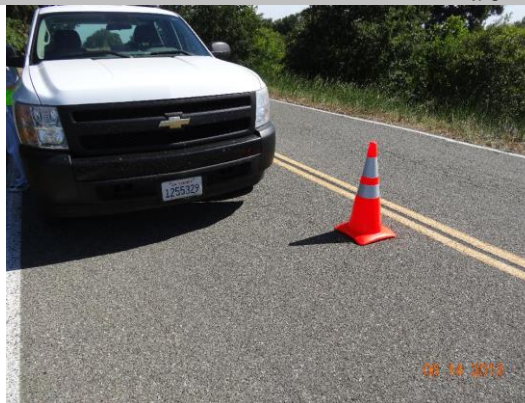
Photo 1 of 3 : UCIP_SP_2018_32551_59070.jpg

Comment Code					
Inspector Comment					
FS_ID:32551 DS_ID:21074 EP_NO: N/A Repair Type: Non-Urgent Crossing Status: Found UCIP Comments: Unable to determine status of crossing. Pipe visible on waterward side--could be the pipe that was supposed to be removed under permit number 13983 (1985). Also present is a 1.5 inch conduit along the 8 inch pipe. Need to coordinate with owner. FIELD_STRUCT_DESC: 8-inch steel irrigation discharge pipe through the levee, 6.4 feet below the crown. Pump on a pile structure in the stream. Service pole on the landside (LS) slope. (8-inch pipe should have been removed and replaced with a 12-inch pipe authorized under Permit No. 13983, 1984 - Mrs. John Thomas). [Additional Reference(s): DWR Levee Log, 2005. USACE Sacramento O&M Manual 105, April 1959, (HLM 1.3)]. FS Date: 6/13/2013

View of levee crown at crossing.

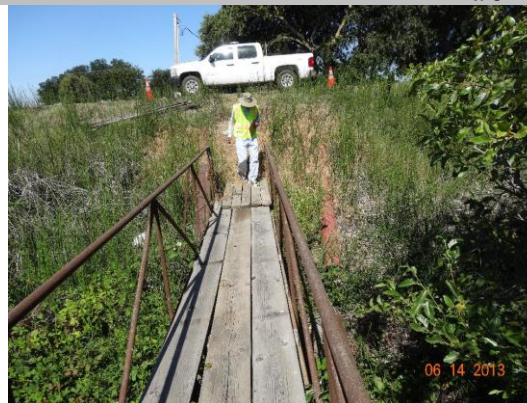
Photo 2 of 3 : UCIP_SP_2018_32551_59072.jpg

Comment Code						
Inspector Comment						
FS_ID:32551						
DS_ID:21074						
EP_NO: N/A						
Repair Type: Non-Urgent						
Crossing Status: Found						
UCIP Comments: Unable to determine status of crossing. Pipe visible on waterward side--could be the pipe that was supposed to be removed under permit number 13983 (1985). Also present is a 1.5 inch conduit along the 8 inch pipe. Need to coordinate with owner.						
FIELD_STRUCT_DESC: 8-inch steel irrigation discharge pipe through the levee, 6.4 feet below the crown. Pump on a pile structure in the stream. Service pole on the landside (LS) slope. (8-inch pipe should have been removed and replaced with a 12-inch pipe authorized under Permit No. 13983, 1984 - Mrs. John Thomas). [Additional Reference(s): DWR Levee Log, 2005. USACE Sacramento O&M Manual 105, April 1959, (HLM 1.3)].						
FS Date: 6/13/2013

Abandoned pipe to the right of walkway.

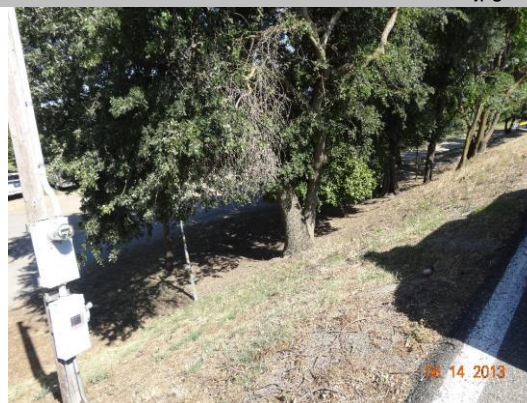
Photo 3 of 3 : UCIP_SP_2018_32551_59071.jpg

View of landward side--power pole on slope.

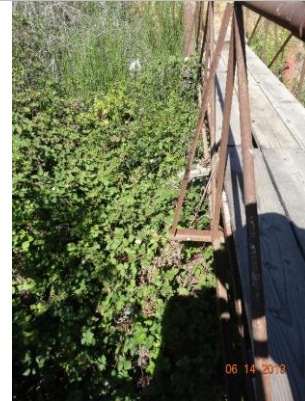
Photo 3 of 3 : UCIP_SP_2018_32552_59075.jpg

Comment Code					
Inspector Comment					
FS_ID:32552 DS_ID:21095 EP_NO: 13983 Repair Type: Non-Urgent Crossing Status: Found UCIP Comments: Abandoned pipe was to be removed during the installation of new 12-inch pipe crossing. Need to contact pipe owner. Unable to confirm crossing--need additional records for crossing. FIELD_STRUCT_DESC: 12-inch coated steel irrigation discharge pipe through the levee, 5 feet below the crown. Cutoff wall around the pipe at the center of the levee. Siphon breaker at the apex of the pipe on the landside (LS) shoulder. Pump on a pile structure in the stream. Service pole on the LS slope. Pipe connects to a 10-inch steel pipe along the LS slope at the shoulder and similarly to a preexisting 8-inch pipe on the waterside (WS). (8-inch pipe should have been removed and replaced with a 12-inch pipe authorized under Permit No. 13983, 1984 - Mrs. John Thomas). FS Date: 6/13/2013

Pipe suspended on waterward side along walkway.

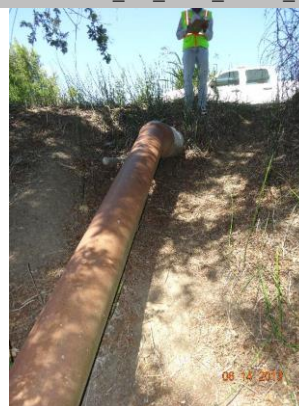
Photo 1 of 3 : UCIP_SP_2018_44471_33491.jpg

Comment Code						
Inspector Comment						
FS_ID:44471 DS_ID:21076 EP_NO: 16906 Repair Type: Non-Urgent Crossing Status: Found UCIP Comments: Crossing was running during site inspeciton. Dense vegetation limits the inspector's visibility to identify signs of pipe failure (leaks) along the landward slope. Recommend removing vegetation along pipe alignment to conduct proper inspection of structure and appurtenances. FIELD_STRUCT_DESC: 14-inch coated steel irrigation discharge pipe through the levee, 2.2 feet below the crown. Pump on a pile structure in the stream. Concrete standpipe on the landside (LS). Pipe exposed on the LS slope. Two conduits present: 3-inch conduit is disconnected, and 1.5-inch electrical conduit appears to be active. (Plans to replace an existing 10-inch pipe with a 14-inch irrigation pipe through the levee authorized under Permit No. 16906, 1998 - Neil R. Hamilton/DCC Engineering Company). [Additional Reference(s): DWR Levee Log, 2005]. FS Date: 6/13/2013

Waterward side-pipe along slope.

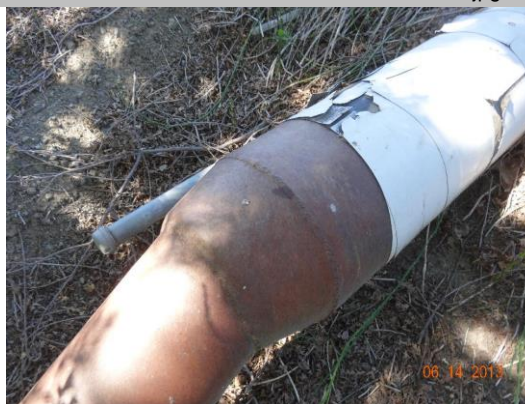
Photo 2 of 3 : UCIP_SP_2018_44471_33495.jpg

Pipe section reduced at the waterward side daylight.

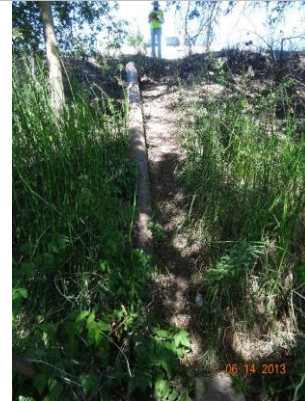
Photo 3 of 3 : UCIP_SP_2018_44471_33496.jpg

Comment Code						
Inspector Comment						
FS_ID:44471 DS_ID:21076 EP_NO: 16906 Repair Type: Non-Urgent Crossing Status: Found UCIP Comments: Crossing was running during site inspeciton. Dense vegetation limits the inspector's visibility to identify signs of pipe failure (leaks) along the landward slope. Recommend removing vegetation along pipe alignment to conduct proper inspection of structure and appurtenances. FIELD_STRUCT_DESC: 14-inch coated steel irrigation discharge pipe through the levee, 2.2 feet below the crown. Pump on a pile structure in the stream. Concrete standpipe on the landside (LS). Pipe exposed on the LS slope. Two conduits present: 3-inch conduit is disconnected, and 1.5-inch electrical conduit appears to be active. (Plans to replace an existing 10-inch pipe with a 14-inch irrigation pipe through the levee authorized under Permit No. 16906, 1998 - Neil R. Hamilton/DCC Engineering Company). [Additional Reference(s): DWR Levee Log, 2005]. FS Date: 6/13/2013

Overview of waterward side.

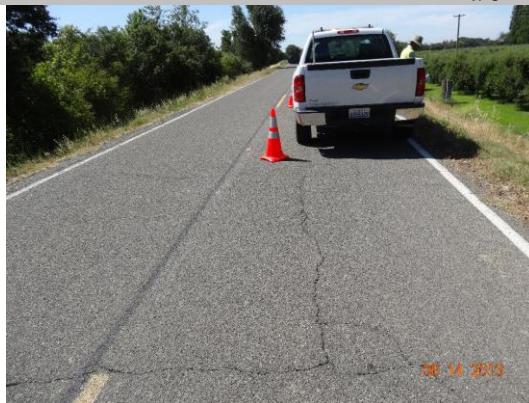
Photo 1 of 3 : UCIP_SP_2018_32553_59082.jpg

Comment Code					
Inspector Comment					
FS_ID:32553 DS_ID:21077 EP_NO: N/A Repair Type: Non-Urgent Crossing Status: Found UCIP Comments: Dense vegetation limits the inspector's visibility to identify signs of pipe failure (leaks) along the waterward and landward slope. Recommend removing vegetation along pipe alignment to conduct proper inspection of structure and appurtenances. FIELD_STRUCT_DESC: 14-inch steel irrigation discharge pipe through the levee, 8 feet below the crown. 2-inch electrical conduit of an unknown material through the levee, at an unknown depth. Siphon breaker on the landside (LS) slope. Pump on a pile structure in the stream. [Additional Reference(s): DWR Levee Log, 2005. USACE Sacramento O&M Manual 105, April 1959, (HLM 2.0)]. FS Date: 6/13/2013

View of levee crown at crossing.

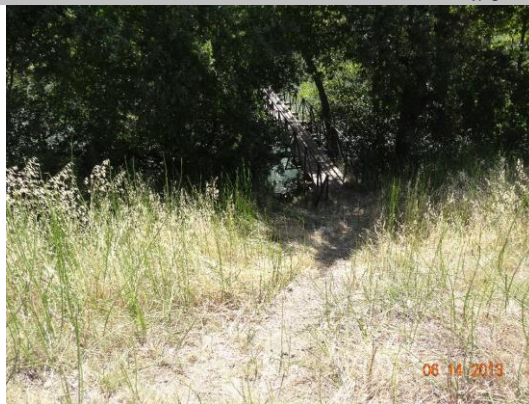
Photo 2 of 3 : UCIP_SP_2018_32553_59081.jpg

View of waterward side.

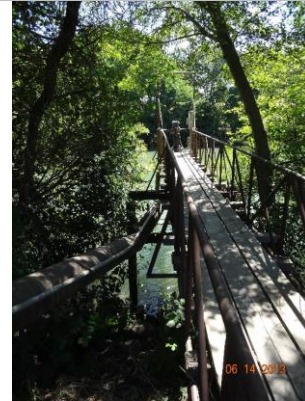
Photo 3 of 3 : UCIP_SP_2018_32553_59080.jpg

Comment Code						
Inspector Comment						
FS_ID:32553 DS_ID:21077 EP_NO: N/A Repair Type: Non-Urgent Crossing Status: Found UCIP Comments: Dense vegetation limits the inspector's visibility to identify signs of pipe failure (leaks) along the waterward and landward slope. Recommend removing vegetation along pipe alignment to conduct proper inspection of structure and appurtenances. FIELD_STRUCT_DESC: 14-inch steel irrigation discharge pipe through the levee, 8 feet below the crown. 2-inch electrical conduit of an unknown material through the levee, at an unknown depth. Siphon breaker on the landside (LS) slope. Pump on a pile structure in the stream. [Additional Reference(s): DWR Levee Log, 2005. USACE Sacramento O&M Manual 105, April 1959, (HLM 2.0)]. FS Date: 6/13/2013

Waterward side--catwalk, conduit line, pump, and support piles.

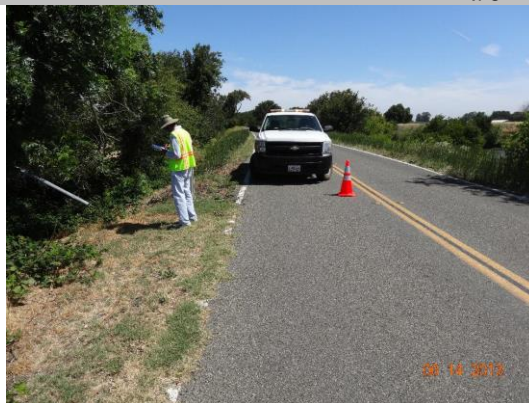
Photo 1 of 3 : UCIP_SP_2018_32863_59483.jpg

FS_ID:32863
DS_ID:21078
EP_NO: N/A
Repair Type: Non-Urgent
Crossing Status: Found
UCIP Comments: Broken concrete box on landward slope. Disturbed soil on waterward slope--unable to determine section disturbed. Dense vegetation limits the inspector's visibility to identify signs of pipe failure (leaks) along the waterwar slope. Recommend removing vegetation along pipe alignment to conduct proper inspection of structure and appurtenances.
FIELD_STRUCT_DESC: *ABANDONED* 6-inch and working 6-inch steel irrigation discharge pipes through the levee, 2.5 feet and 5 feet below the crown, respectively. Pipes are within 5 feet of each other. 1.5-inch electrical conduit of an unknown material through the levee, at an unknown depth. Pump in a pump house on the waterside (WS) slope.
[Additional Reference(s): DWR Levee Log, 2005. USACE Sacramento O&M Manual 105, April 1959, (HLM 2.3)].
FS Date: 6/13/2013

View of levee crown at crossing.

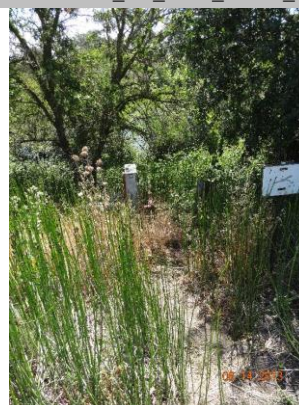
Photo 2 of 3 : UCIP_SP_2018_32863_59484.jpg

View of waterward side with dense vegetation along slope.

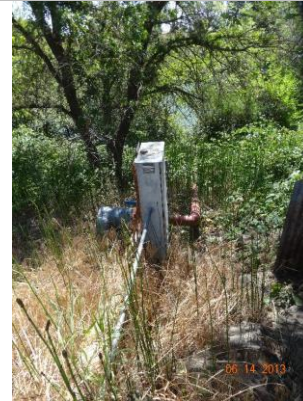
Photo 3 of 3 : UCIP_SP_2018_32863_59480.jpg

Comment Code						
Inspector Comment						
FS_ID:32863 DS_ID:21078 EP_NO: N/A Repair Type: Non-Urgent Crossing Status: Found UCIP Comments: Broken concrete box on landward slope. Disturbed soil on waterward slope--unable to determine section disturbed. Dense vegetation limits the inspector's visibility to identify signs of pipe failure (leaks) along the waterwar slope. Recommend removing vegetation along pipe alignment to conduct proper inspection of structure and appurtenances. FIELD_STRUCT_DESC: *ABANDONED* 6-inch and working 6-inch steel irrigation discharge pipes through the levee, 2.5 feet and 5 feet below the crown, respectively. Pipes are within 5 feet of each other. 1.5-inch electrical conduit of an unknown material through the levee, at an unknown depth. Pump in a pump house on the waterside (WS) slope. [Additional Reference(s): DWR Levee Log, 2005. USACE Sacramento O&M Manual 105, April 1959, (HLM 2.3)]. FS Date: 6/13/2013

View of waterward side--conduit, pump, control panel, and pipe. Soil piled on right corner of photo--excavation?
